Pipeline inspection with thermal diagnostics

Introduction to the issue

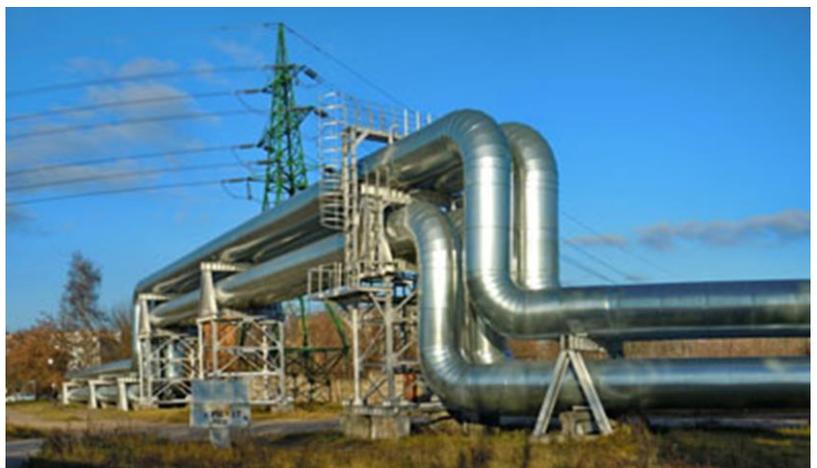
A pipeline is technological equipment that transfers heat used to heat residential and public buildings or whole towns.

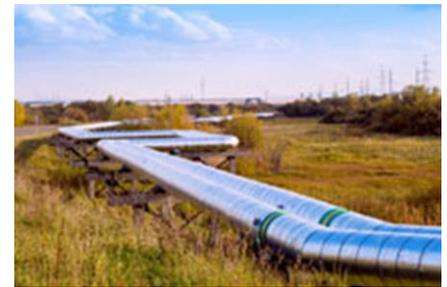
This hot-water pipeline appears to be fine during visual inspections. As we will mention later, there are many thermal bridges on this pipeline that reduce the efficiency of the transport of thermal energy. Traditional cameras do not detect defects on internal heat insulation and leaks below the surface of the ground.

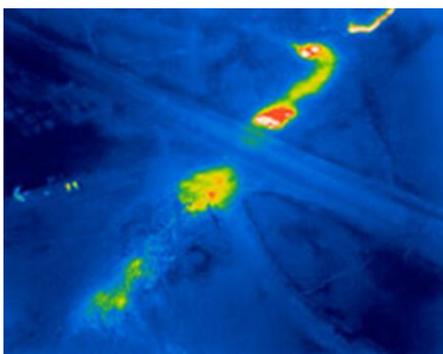
A hot-water pipeline heats the surface of the ground and, therefore, can be detected by a thermal camera located on the drone. Using this camera, areas can be detected where the pipeline is broken or where the penetration of hot water heats up the affected earth.

A traditional camera does not detect defects to internal heat insulation and the escapes of media below the surface of ground. With the timely discovery of areas where the insulation is thinner or where the cladding on the tube is damaged, major accidents can be prevented that would result in economic losses and a threat to the health and lives of the public. A thermal camera can detect such defects and record the thermal radiation of objects. On the basis of the difference to the surface of the pipeline and the experience of the operator, hidden defects can be found. It is easy to

identify where the insulation is damaged and heat losses occur (during the transport of heating media). In the case of underground pipelines, any penetration of hot water causes the affected earth to heat up so it is possible to discover where the pipeline is broken underground. This means that, it is no longer necessary to excavate kilometres of pipelines due to the discovery of the place of escape. The different temperature of the background and thin areas mean there is a risk of the pipe breaking so timely intervention may prevent fatal consequences.

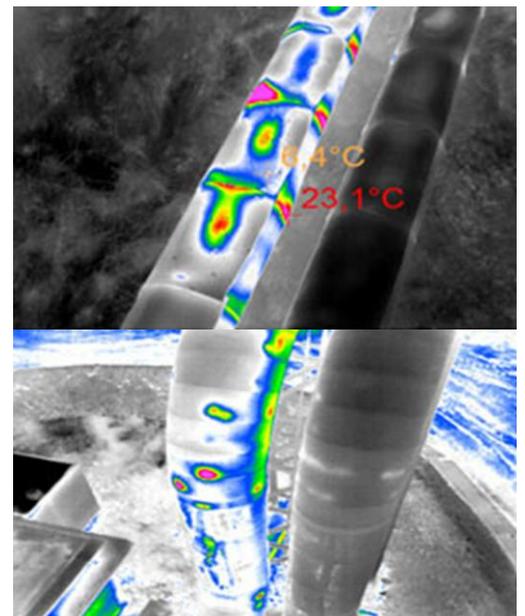
Although in the visible spectrum this hot-water pipeline is completely without defects, the measurement of thermal camera shows that on the left hot-water pipeline there are a series of thermal bridges resulting in thermal losses.
