Thermodiagnostics in the power engineering sector

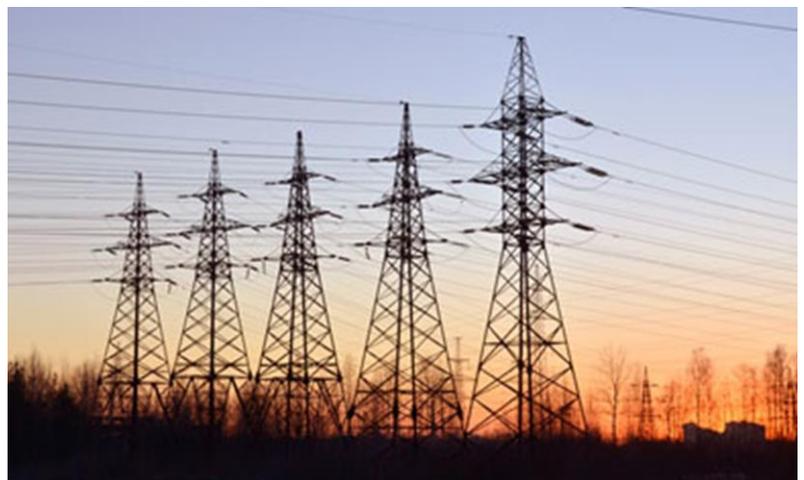
Columns and distribution lines for high voltage networks.

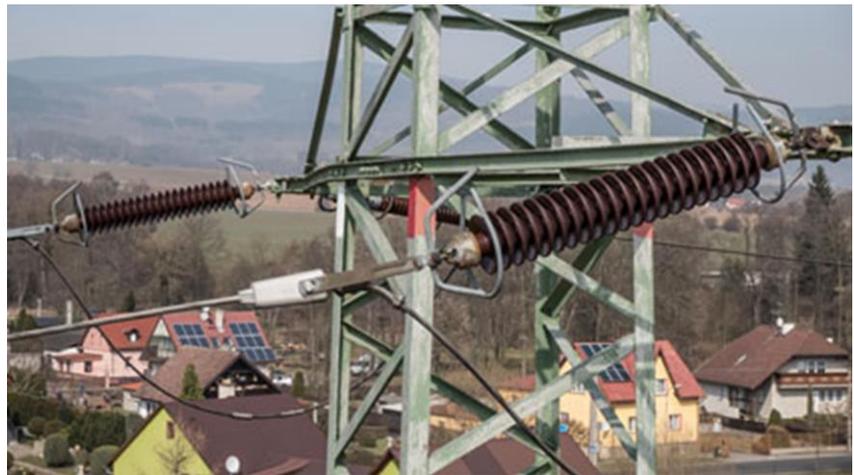
Joint on the high voltage distribution line. The place where a problem may occur, i.e. origination of transient resistance with consequent overheating.

One of the most frequent failures in the distribution network is the overheating of individual components due to transition resistance. Transition resistance occurs in imperfect places (damaged, outdated or unprofessionally installed) electric joints.

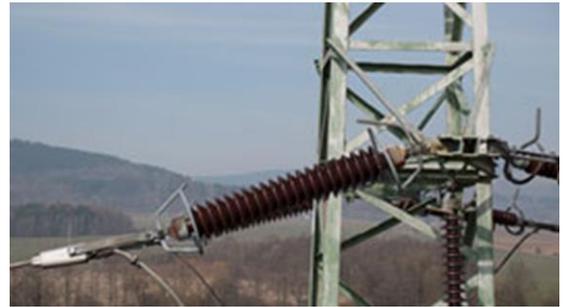
Photographic image from an aviation inspection of high-voltage distribution lines. Although there is nothing to be seen on the photo, there is a defect on the joint in the form of high transient resistance. The electric joint has become overheated and according to the recommendation in ISO 18434-1 should be repaired as soon as possible.

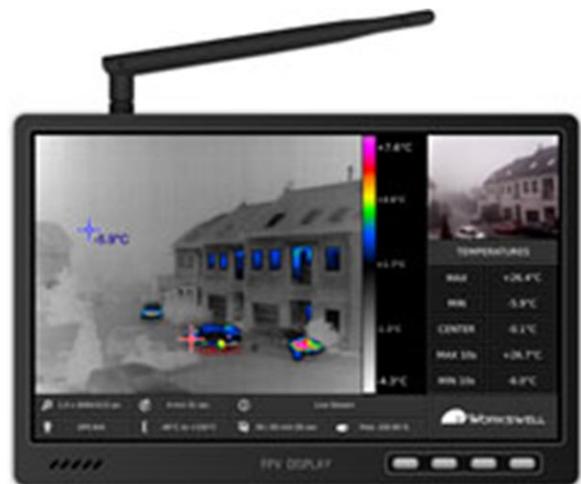
Workswell WIRIS can be fully controlled by a traditional RC controller from which all system functions can be accessed. In addition to all functions, the monitor displays images from the thermal camera as well as colour camera. Information is available about the measured temperature (min/max and central spot) during the flight.
